## APPENDIX 14

### ENDANGERED AND THREATENED SPECIES BIOLOGICAL ASSESSMENT

# YAZOO BACKWATER AREA REFORMULATION

## APPENDIX 14 ENDANGERED AND THREATENED SPECIES BIOLOGICAL ASSESSMENT

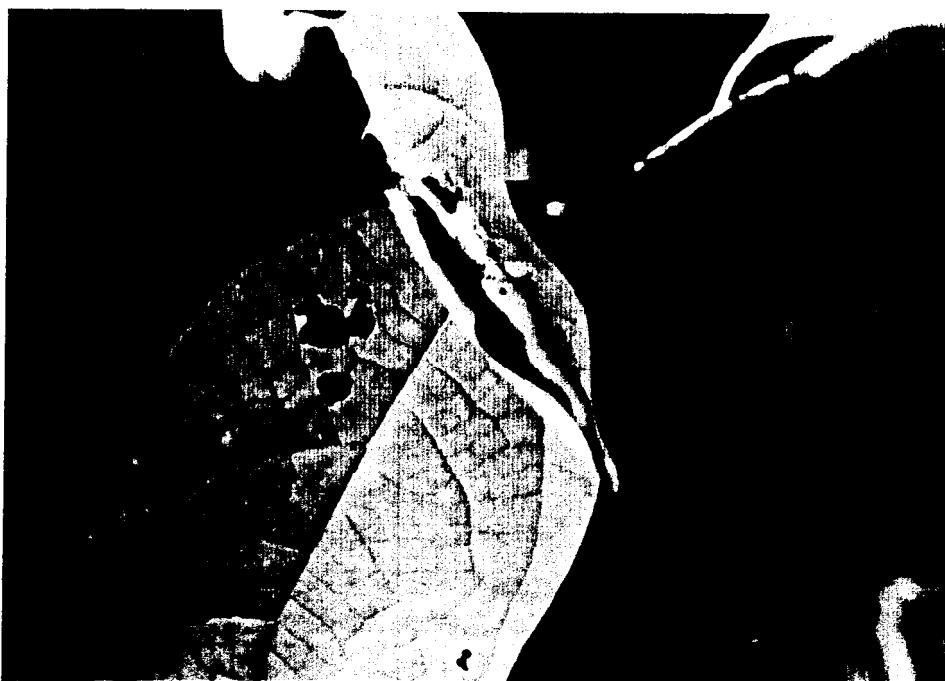
Photograph 3. Spicebush swallowtail caterpillar  
(Pterourus troilus) on pondberry.

The general health of the colony was a subjective value based upon the ratio of dying stems to live stems, physical appearance of the leaves and stems, the density of the colony and the magnitude of insect damage (Photograph 3).

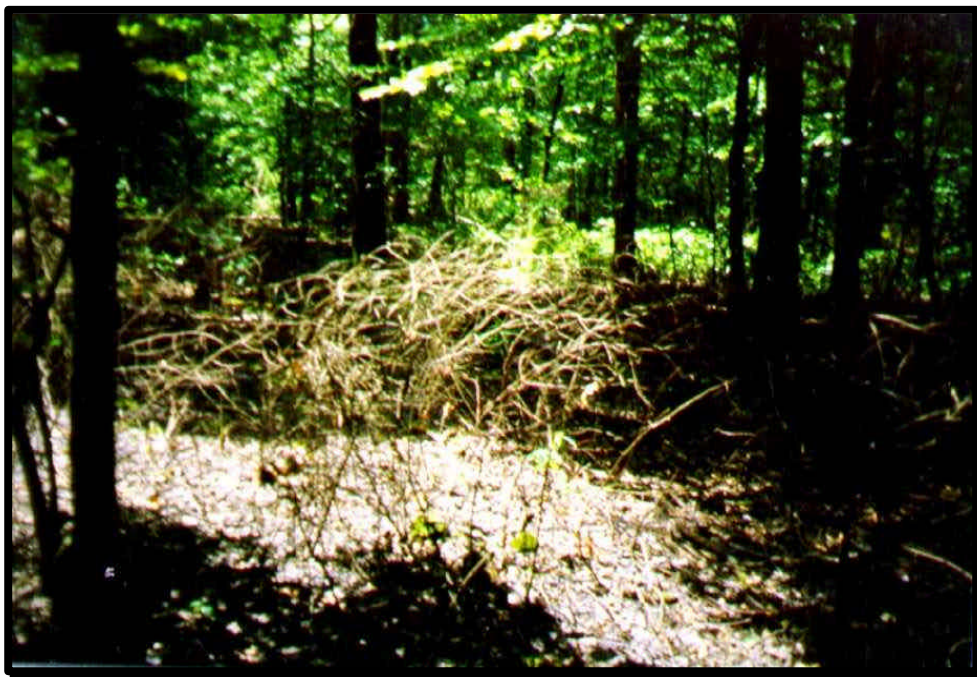
**Figure 9**  
**Pondberry colony with dead stems in Bolivar County (near Shelby)**

Interestingly, pondberry colonies found in Bolivar County, approximately 65 miles north, differed from colonies found in the DNF. Colonies near Shelby were large, healthy colonies; however, one parcel of land contained colonies with very high amounts of dieback and dead stems (Figure 9). It was suggested at the June 22, 2000 workshop by Margaret Devall of the Center for Bottomland Hardwood Research that this die-off was caused by abnormally low temperatures during late winter 1999.
